DAVID BOWNES, CHRIS NIX, AND SIDDY HOLLOWAY, WITH SAM MULLINS  
LONDON TRANSPORT MUSEUM IN ASSOCIATION WITH YALE UNIVERSITY PRESS

# HIDDEN LONDON

REDISCOVERING  
THE FORGOTTEN UNDERGROUND

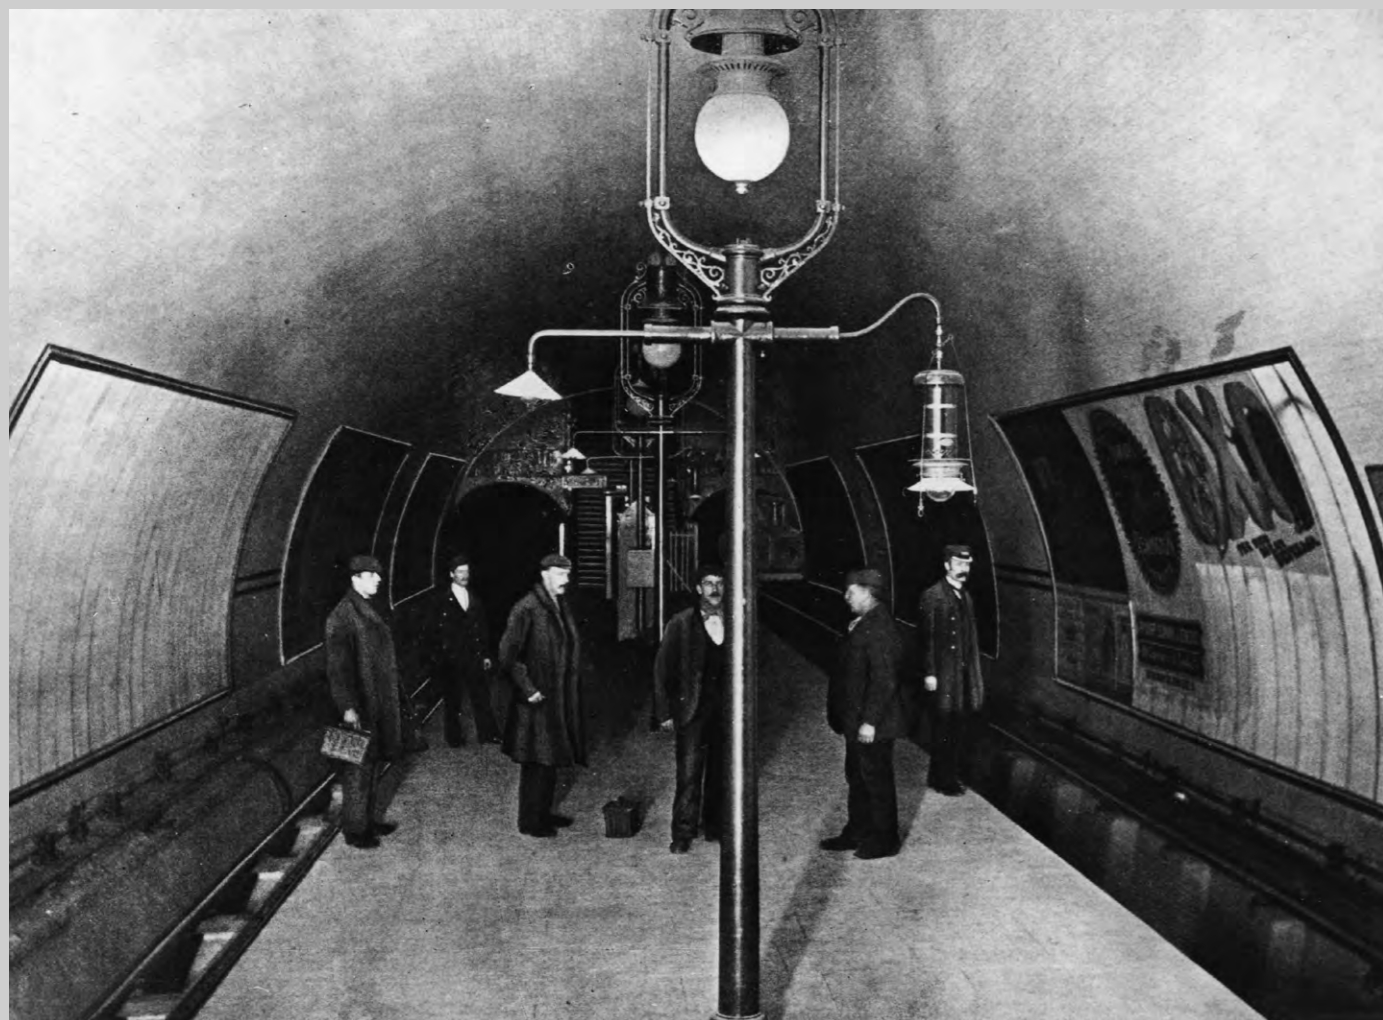
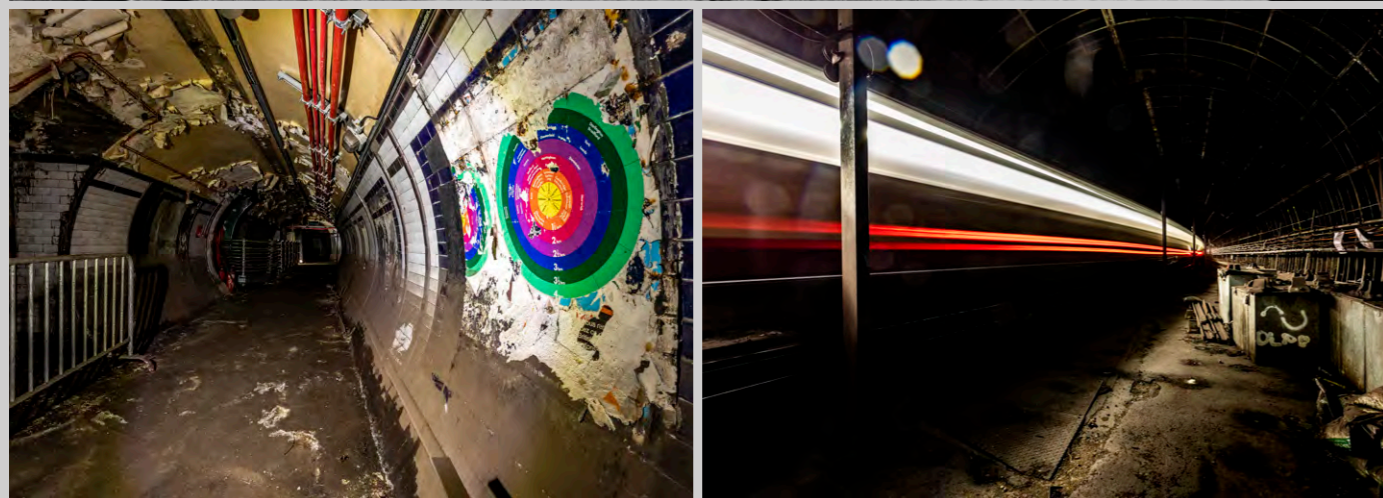
FIG.34—The narrow C&SLR island platform at Angel around 1901 (top image). It was not until Angel station was fitted with escalators in 1993 to accommodate increased passenger numbers that the opportunity was also taken to replace the dangerous platform layout. A new northbound platform tunnel was constructed, and the island platform filled in on one side to make the wide southbound platform we see today (bottom image).

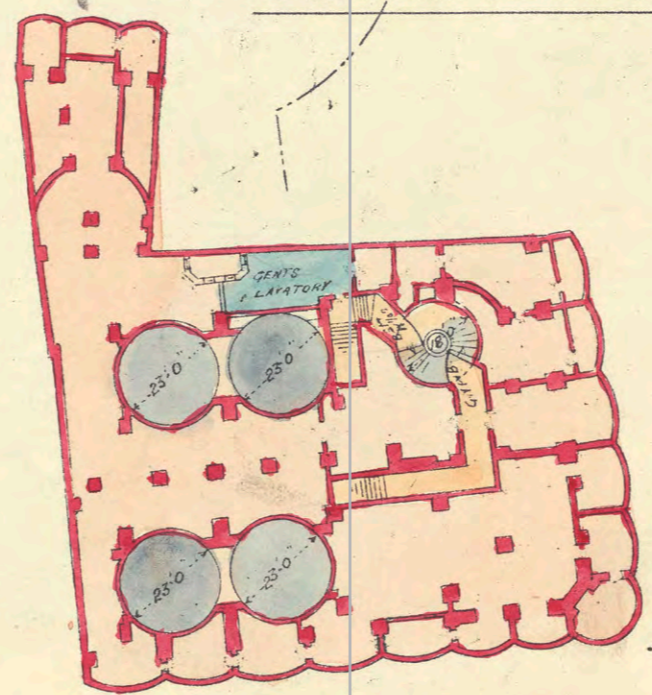
BASEMENT PLAN.

Note:- The Datum to which all levels on this plan refer is 100 feet below Ordnance datum.
